Project Experience

Asbestos Encapsulation

Project Information

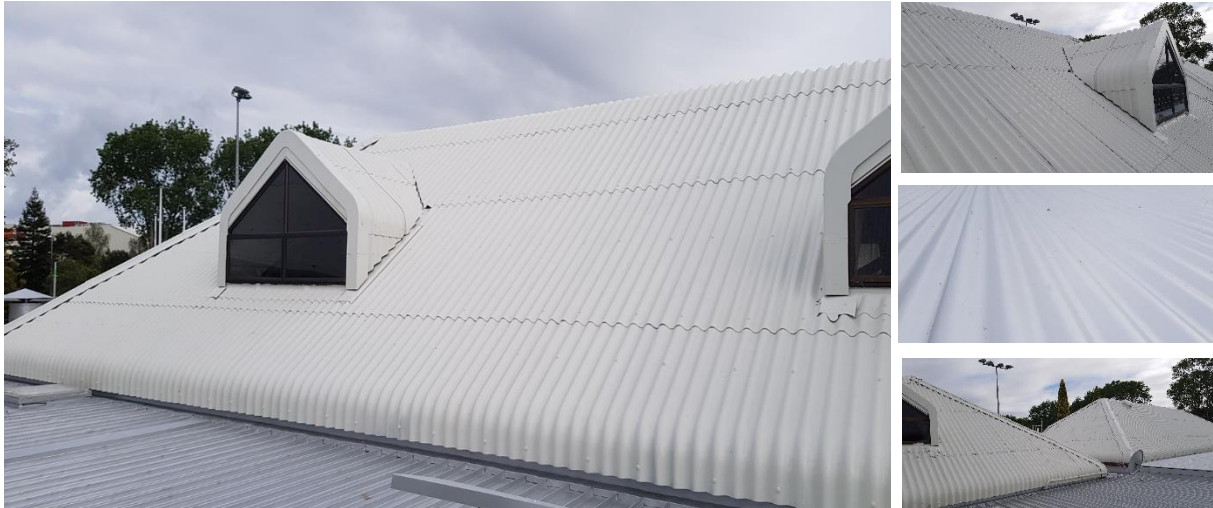
The Henderson Bowling Club asbestos roof, was built in the 1920's, had never been painted. It was deteriorating and releasing friable asbestos fibres, which was of course really dangerous to anyone in the nearby vicinity.

The Auckland Council chose to apply MCU-Coatings for various reasons:

- *its ability to be applied on a water assisted, brush cleaned surface without the need for abrasive cleaning (which would not have been allowed in New Zealand for safety reasons)*
- *the ability for MCU-Miomastic to penetrate deep into the porous surface of the asbestos to encapsulate the fibres in a polyurea coating, thereby preventing the fibres from ever becoming friable*
- *the rapid cure and need to complete the project in a short project time frame; and*
- *ability that the coating has to flex with the expansion and contraction of the roof without cracking or peeling*

It was interesting that the encapsulation and restoration was deemed to be far safer and less hazardous than if the roof had been removed and disposed of.
