## Project information – Cooling Towers

**Location:** Romania  
**Project:** Maintenance

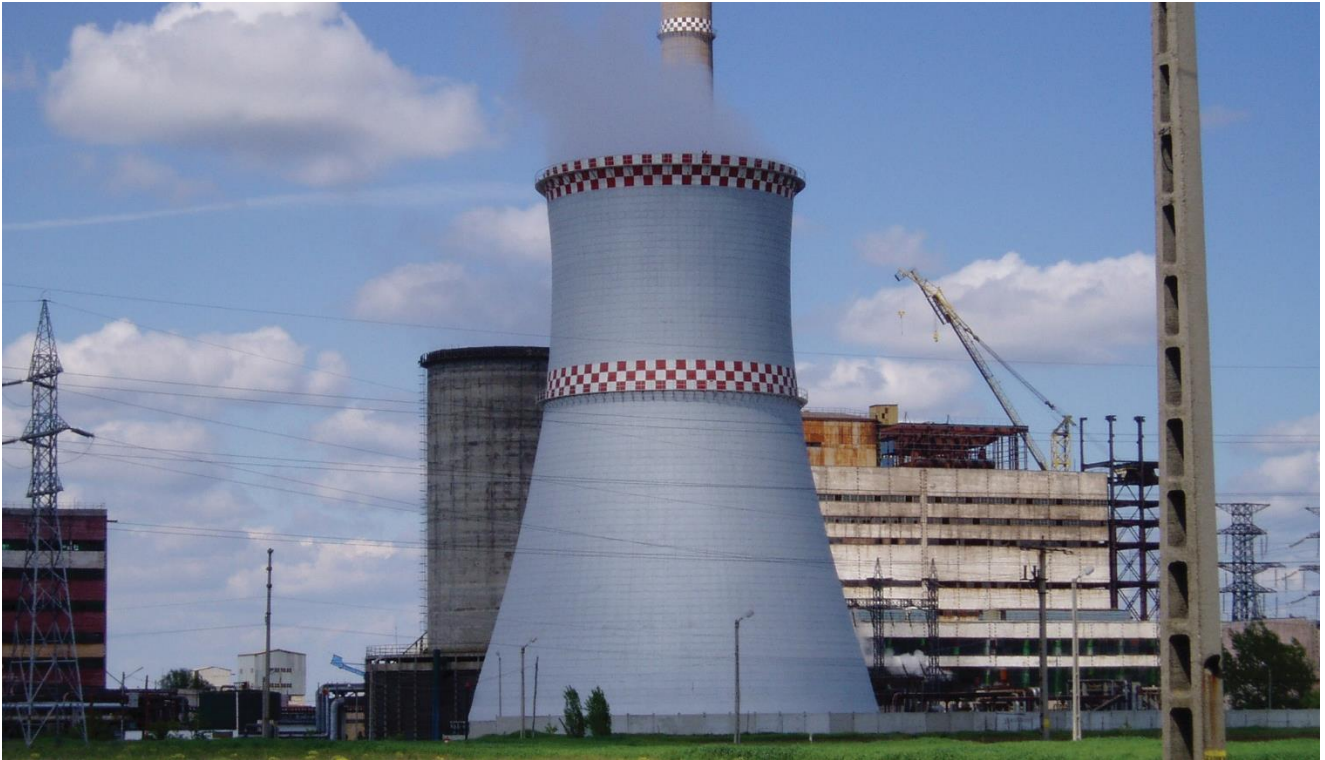
Around 60 older concrete cooling towers needed urgent renovation due to failing concrete. After concrete repair a thinned layer of MCU-Mastic was applied to penetrate well in the porosity. A finish of MCU-Mastic and MCU-Topcoat was applied on the exterior side and MCU-Ferroguard on the internal side.

MCU-Coatings' paints was the easiest to handle (1 component and no potlife for roller application) and tolerant coating system for these jobs and still offering a very durable and long-term protection. MCU-Mastic and MCU-Ferroguard can be applied direct to concrete.
