## Project Experience

### OEM – Industrial fan rooms

### Project information

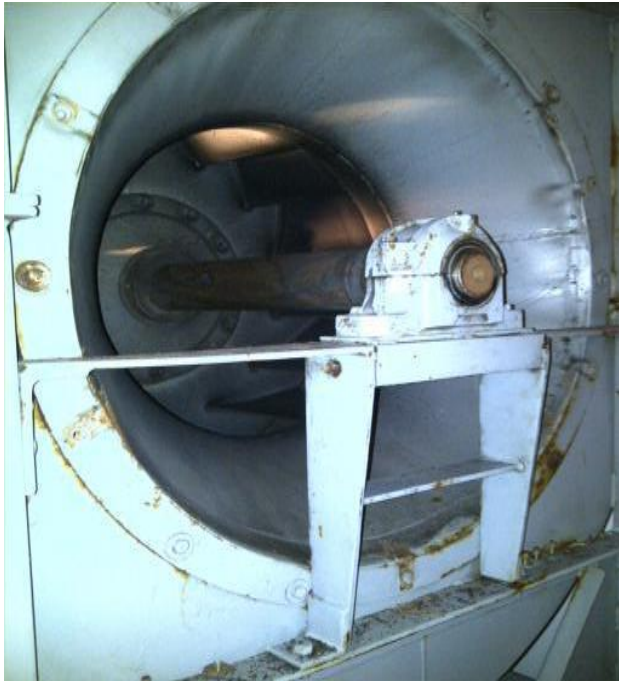
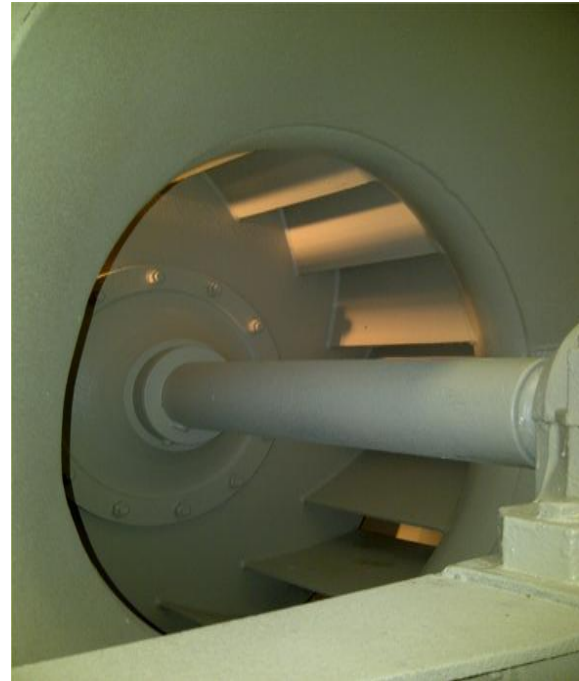
<b>location</b>	South Africa
<b>client</b>	Toyota Manufacturing TASM
<b>project</b>	Industrial fan rooms refurbishment
<b>climatic conditions</b>	Summer 30°C 80-98% RH
<b>substrate</b>	
<b>surf. Preparation</b>	St 3, Sa 2,5, UHP
<b>system</b>	MCU-Miozinc MCU-Miomastic MCU-Alutopcoat

*MCU-Coatings have been specified for their high abrasion and hard wearing properties as well as resistance to particularly high humidity levels. The added benefits also include long term maintenance as MCU-Coatings' unique coatings resist rust creep. Therefore after many years in service a simple spot repair and touch is required drastically reducing long term corrosion maintenance.*

*The refurbishments were undertaken in continuous 36 hours work shift with no restriction to application and allowing the fans to be put back into service only hours after completion.*
