## Project Experience Marine

**location** Falkenberg shipyard,  
Sweden

**project** Chemical Tanker  
4000DWT  
Hull treatment tanker

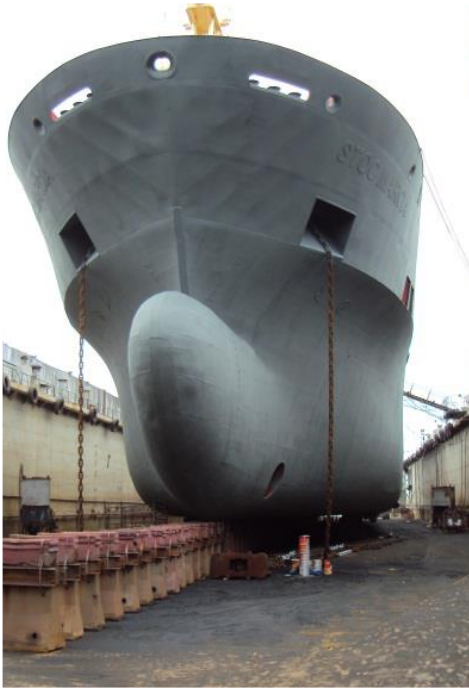
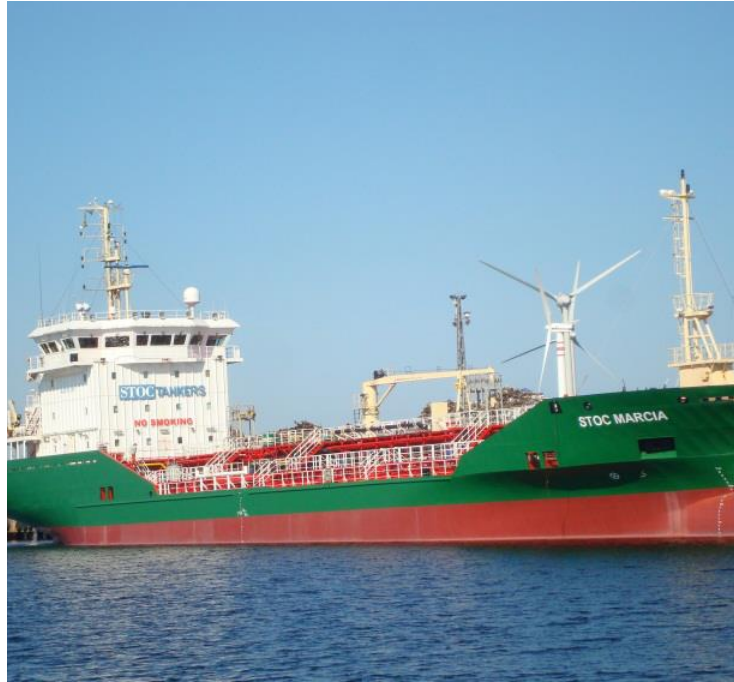
*Vessel is built 2007 and painted with a known brand but the over coating intervals was not followed.*

*Technical department of MCU-Coatings was contacted to assist. Vessel was docked and spot blasted Sa 2 to remove the rust and rest of the hull was swept to locate the poor adhesion areas.*

*Touch-up done by MCU-Miozinc and a second layer of MCU-Miozinc was applied to seal the remaining of the old paint system that was in good order.*

*A layer of MCU-Aluprime was applied to the bow section to give the paint system the strength to handle the vessels trade in meters of ice during wintertime in northern Finland.*
