Project Experience

Marine

Project Information

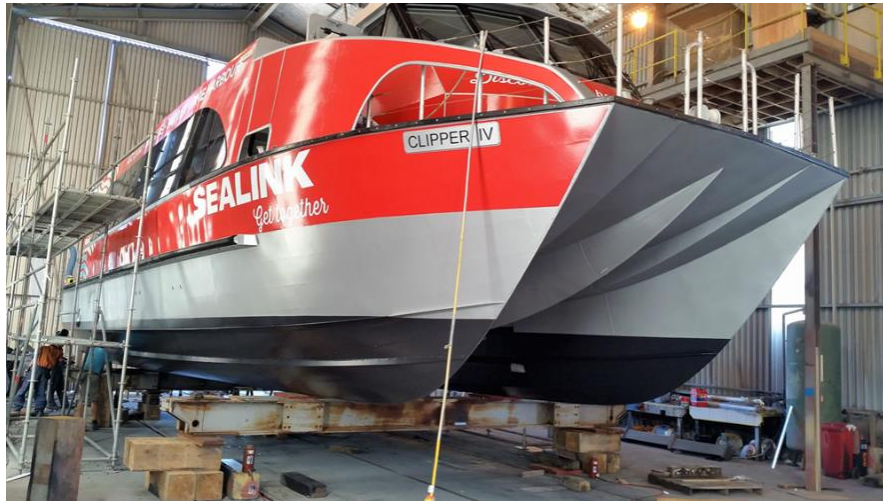
This ferry was only 18 months old and corrosion was present all over the vessel and actual holes evident in the centre tunnel section

location	New Zealand
client	Sealink
project	Ferry refurbishment
date of project	December 2017
climatic conditions	Summer 26°C
substrate	Aluminium
surface preparation	SSPC-SP WJ-1/NACE WJ-1
system	MCU-Aluprime MCU-Alutopcoat

- *its ability to be applied on a SSPC-SP WJ-1/NACE WJ-1 prepared surface without the need of grit blasting*
- *the ability for MCU-Aluprime to achieve 25Mpa adhesion on a 50-60µm profiled surface*
- *the coating's ability to be applied in high humidity*
- *the coating's rapid cure and need to complete the project in a short project time frame*
- *high impact and abrasion resistance; and*
- *ability that the coating has to flex with the aluminium skin as the ferry pounds its way through the ocean swell*
