### Ports and harbours – sheets and pilings

**Location** Dorset, United Kingdom  
**Client** Dorset Government  
**Project** New sheet piling

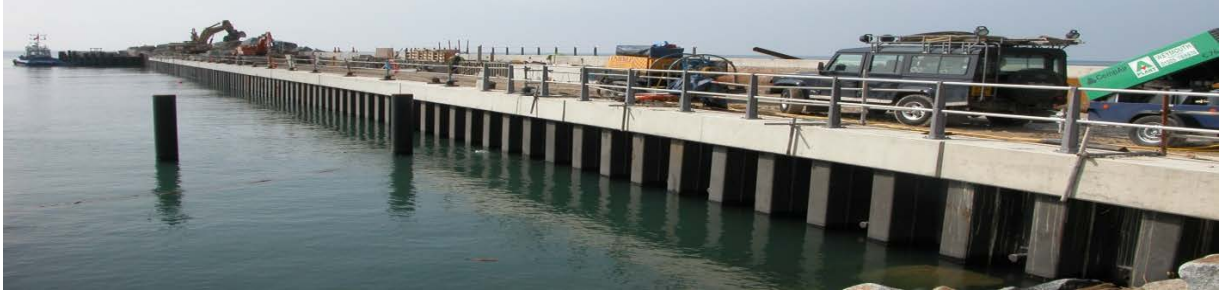
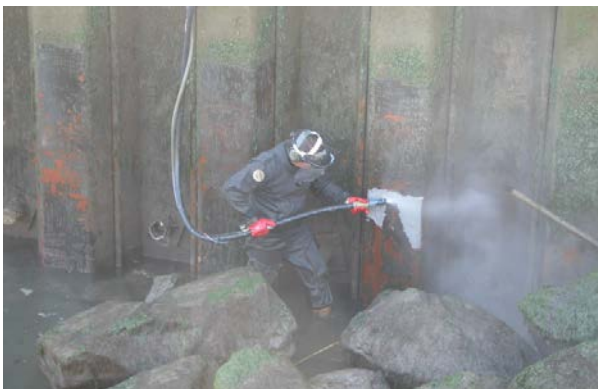
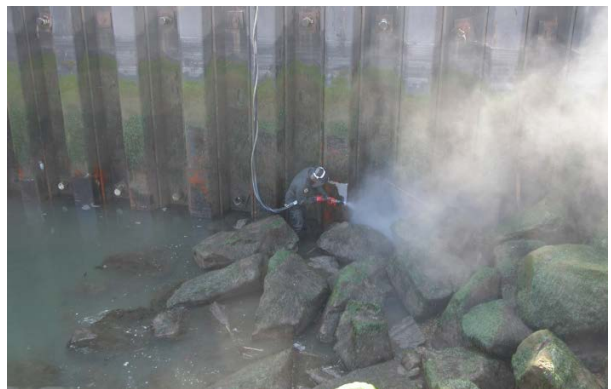
*MCU-Coatings was called in to repair the sheet pile coating as the original coating was damaged as the armor rock was placed in the water around the steelwork as part of the break-water to the new harbour. The problem they had was the limited time they had at low water to carry the works out combined with high moisture and salts on the surface of the steel. The surface was prepared with Wet Abrasive Blasting using fresh water to remove any of the old and damaged coating along with a sweep blast to the surrounding area.*

MCU-Miozinc + MCU-Quickcure  
 MCU-Miomastic + MCU-Quickcure  
 MCU-Miotopcoat + MCU-Quickcure

*MCU-Coatings products can be quickly immersed and will cure further under water. In between tides, only a fresh water wash is needed to apply the next coating. MCU's MCU-MIOTOPCOAT is an aliphatic and perfect immersion resistant finish coating for maximum protection.*
